**Test Report n° TR 036019-01.1**

Date of receipt:	14/06/2019	<b>For the attention of OMP S.R.L. Via Cà Leoncino 2 31030 CASTELLO DI GODEGO (TV)</b>	
Start of the test:	18/06/2019		
End of the test:	18/06/2019		
Sample identification:	Canova identified with code <b>036019-01-01</b>		
Standard:	<b>UNI EN 16139:2013 + UNI EN 1728:2012</b>	Title:	<b>Furniture. Strength, durability and safety. Requirements for non-domestic seating. Test 1 Seat and back static load test (Ref. EN 1728:2012, 6.4).</b>

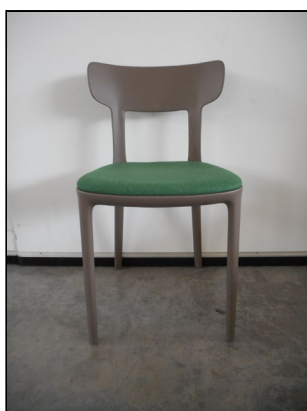
Level	Type of use	Nominal force applied to seat (N)	Nominal force applied to backrest (N)	Number of cycles	Results
2	Extreme use	2000	560*	10	Successful

At the end of the test there is no breakage of any element, joint or component. There are no loosening of joints intended to be rigid. The main structural elements are not significantly deformed. The seat is functional after removal of the test loads. The seat meets the stability requirements.

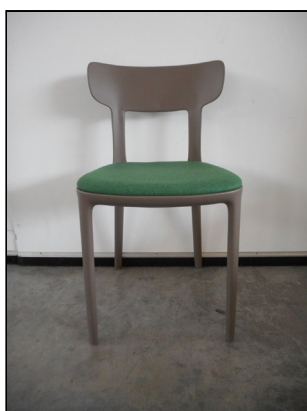
Date of receipt:	14/06/2019	<b>For the attention of OMP S.R.L. Via Cà Leoncino 2 31030 CASTELLO DI GODEGO (TV)</b>	
Start of the test:	18/06/2019		
End of the test:	18/06/2019		
Sample identification:	Canova identified with code <b>036019-01-01</b>		
Standard:	<b>UNI EN 16139:2013 + UNI EN 1728:2012</b>	Title:	<b>Furniture. Strength, durability and safety. Requirements for non-domestic seating. Test 3 Vertical static load on back (Ref. EN 1728:2012, 6.6).</b>

Level	Type of use	Nominal force applied to seat (N)	Nominal force applied to backrest (N)	Number of cycles	Results
2	Extreme use	1800	900	10	Successful

At the end of the test there is no breakage of any element, joint or component. There are no loosening of joints intended to be rigid. The main structural elements are not significantly deformed. The seat is functional after removal of the test loads. The seat meets the stability requirements.

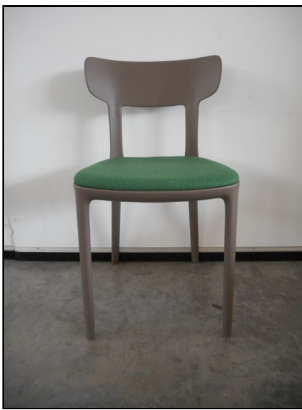
Date of receipt:	14/06/2019	<b>For the attention of OMP S.R.L. Via Cà Leoncino 2 31030 CASTELLO DI GODEGO (TV)</b>	
Start of the test:	18/06/2019		
End of the test:	01/07/2019		
Sample identification:	Canova identified with code <b>036019-01-01</b>		
Standard:	<b>UNI EN 16139:2013 + UNI EN 1728:2012</b>	Title:	<b>Furniture. Strength, durability and safety. Requirements for non-domestic seating. Test 8 Seat and back durability test (Ref. EN 1728:2012, 6.17).</b>

Level	Type of use	Nominal force applied to seat (N)	Nominal force applied to backrest (N)	Number of cycles	Results
2	Extreme use	1000	300	200000	Successful

At the end of the test there is no breakage of any element, joint or component. There are no loosening of joints intended to be rigid. The main structural elements are not significantly deformed. The seat is functional after removal of the test loads. The seat meets the stability requirements.

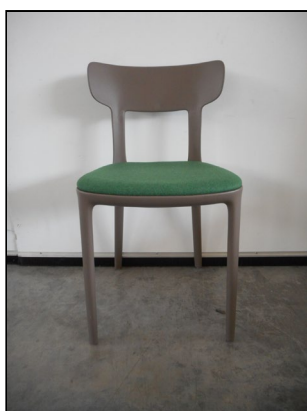
Date of receipt:	14/06/2019	<b>For the attention of OMP S.R.L. Via Cà Leoncino 2 31030 CASTELLO DI GODEGO (TV)</b>	
Start of the test:	02/07/2019		
End of the test:	08/07/2019		
Sample identification:	Canova identified with code <b>036019-01-01</b>		
Standard:	<b>UNI EN 16139:2013 + UNI EN 1728:2012</b>	Title:	<b>Furniture. Strength, durability and safety. Requirements for non-domestic seating. Test 9 Seat front edge durability test (Ref. EN 1728:2012, 6.18).</b>

Level	Type of use	Nominal force applied to seat (N)	Number of cycles	Results
2	Extreme use	800	100000	Successful

At the end of the test there is no breakage of any element, joint or component. There are no loosening of joints intended to be rigid. The main structural elements are not significantly deformed. The seat is functional after removal of the test loads. The seat meets the stability requirements.

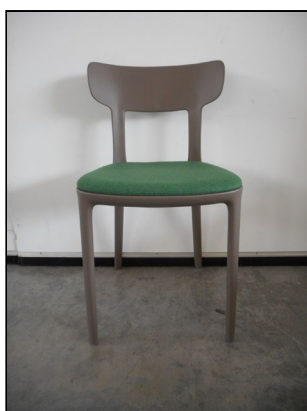
Date of receipt:	14/06/2019	<b>For the attention of OMP S.R.L. Via Cà Leoncino 2 31030 CASTELLO DI GODEGO (TV)</b>	
Start of the test:	18/07/2019		
End of the test:	18/07/2019		
Sample identification:		<b>Canova identified with code 036019-01-01</b>	
Standard:	<b>UNI EN 16139:2013 + UNI EN 1728:2012</b>	Title:	<b>Furniture. Strength, durability and safety. Requirements for non-domestic seating. Test 12 Leg forward static load test (Ref. EN 1728:2012, 6.15).</b>

Level	Type of use	Nominal force applied to seat (N)	Nominal vertical force applied (N)	Number of cycles	Results
2	Extreme use	1800	350*	10	Successful

At the end of the test there is no breakage of any element, joint or component. There are no loosening of joints intended to be rigid. The main structural elements are not significantly deformed. The seat is functional after removal of the test loads. The seat meets the stability requirements.

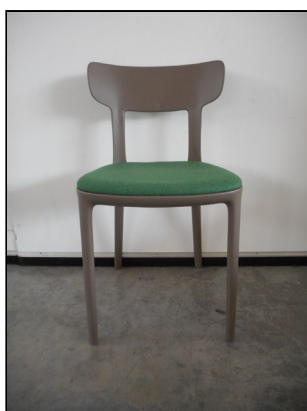
Date of receipt:	14/06/2019	<b>For the attention of OMP S.R.L. Via Cà Leoncino 2 31030 CASTELLO DI GODEGO (TV)</b>	
Start of the test:	18/07/2019		
End of the test:	18/07/2019		
Sample identification:	Canova identified with code <b>036019-01-01</b>		
Standard:	<b>UNI EN 16139:2013 + UNI EN 1728:2012</b>	Title:	<b>Furniture. Strength, durability and safety. Requirements for non-domestic seating. Test 13 Leg sideways static load test (Ref. EN 1728:2012, 6.16).</b>

Level	Type of use	Nominal force applied to seat (N)	Nominal vertical force applied (N)	Number of cycles	Results
2	Extreme use	1800	280*	10	Successful

At the end of the test there is no breakage of any element, joint or component. There are no loosening of joints intended to be rigid. The main structural elements are not significantly deformed. The seat is functional after removal of the test loads. The seat meets the stability requirements.

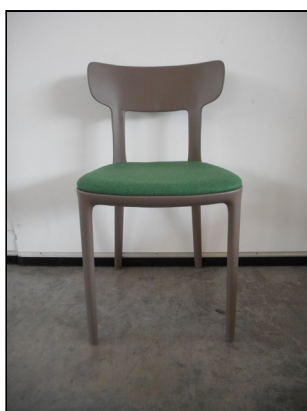
Date of receipt:	14/06/2019	<b>For the attention of OMP S.R.L. Via Cà Leoncino 2 31030 CASTELLO DI GODEGO (TV)</b>	
Start of the test:	19/07/2019		
End of the test:	19/07/2019		
Sample identification:	Canova identified with code <b>036019-01-01</b>		
Standard:	<b>UNI EN 16139:2013 + UNI EN 1728:2012</b>	Title:	<b>Furniture. Strength, durability and safety. Requirements for non-domestic seating. Test 14 Seat impact (Ref. 1728:2012, 6.24).</b>

Level	Type of use	Nominal drop height (mm)	Number of cycles	Results
2	Extreme use	300	10	Successful

At the end of the test there is no breakage of any element, joint or component. There are no loosening of joints intended to be rigid. The main structural elements are not significantly deformed. The seat is functional after removal of the test loads. The seat meets the stability requirements.

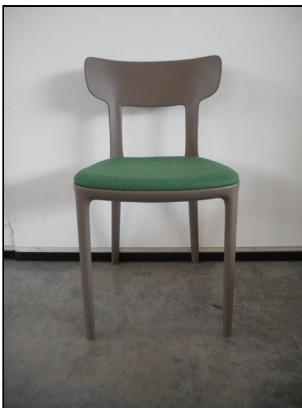
Date of receipt:	14/06/2019	<b>For the attention of OMP S.R.L. Via Cà Leoncino 2 31030 CASTELLO DI GODEGO (TV)</b>	
Start of the test:	19/07/2019		
End of the test:	19/07/2019		
Sample identification:	Canova identified with code <b>036019-01-01</b>		
Standard:	<b>UNI EN 16139:2013 + UNI EN 1728:2012</b>	Title:	<b>Furniture. Strength, durability and safety. Requirements for non-domestic seating. Test 15 Back impact test (Ref. EN 1728:2012, 6.25).</b>

Level	Type of use	Nominal drop height (mm)	Nominal drop angle (°)	Number of cycles	Results
2	Extreme use	330	48	10	Successful

At the end of the test there is no breakage of any element, joint or component. There are no loosening of joints intended to be rigid. The main structural elements are not significantly deformed. The seat is functional after removal of the test loads. The seat meets the stability requirements.
